NEW MEXICO ENVIRONMENT DEPARTMENT

Re: **Greater Kudu/ Project Antelope; CGP; SIC 1541; NPDES Compliance Evaluation Inspection;
NPDES #NMU001949; November 1, 2017**

NPDES Compliance Inspection Report

NPDES Construction General Permit Inspection Report – State of New Mexico

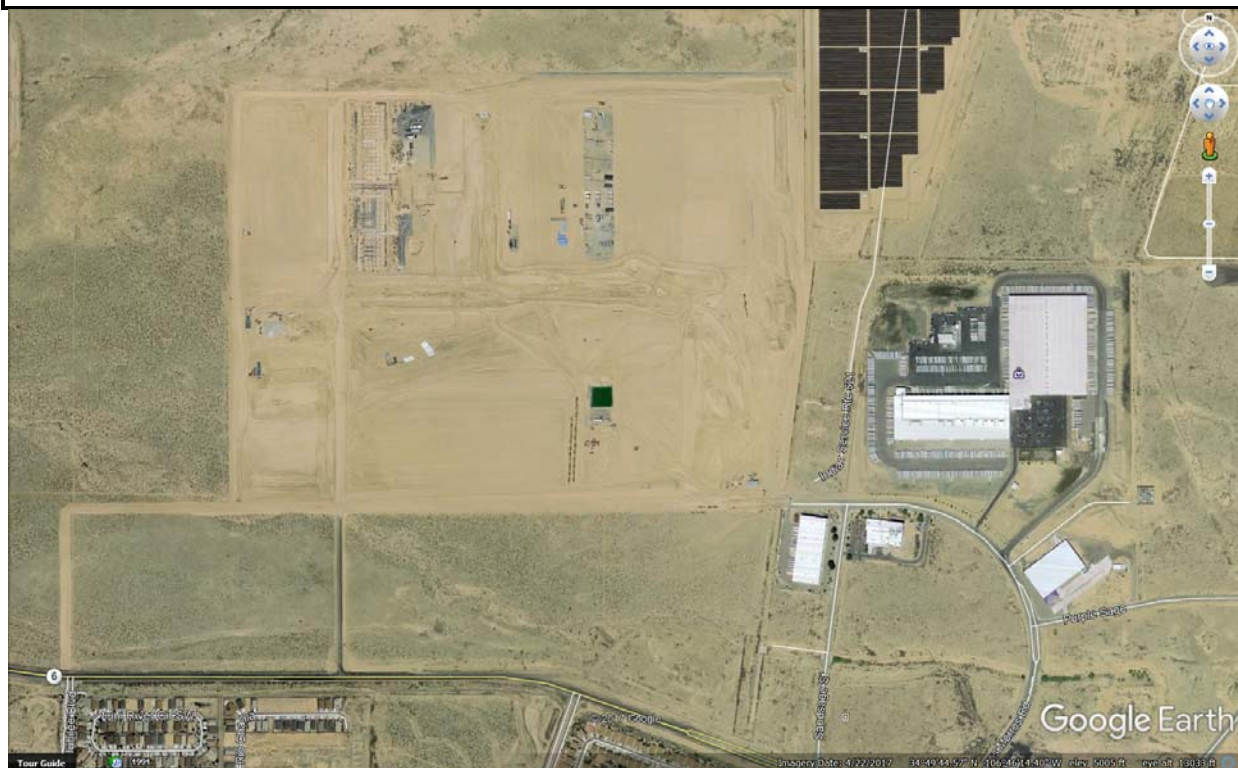
NMED/SWQB Official Photograph Log Photo # 1		
Photographer: Google Earth	Date: 4-22-17	Time: unknown
City/County: Los Lunas/Valencia		State: New Mexico
Location: Project Antelope		
Subject: Aerial view of project in April 2017
